## **Kinetic Super-Resolution Long-Wave Infrared (KSR LWIR) Thermography Diagnostic for Building Envelopes**

Camp Lejeune, NC

August 2015

Final Report

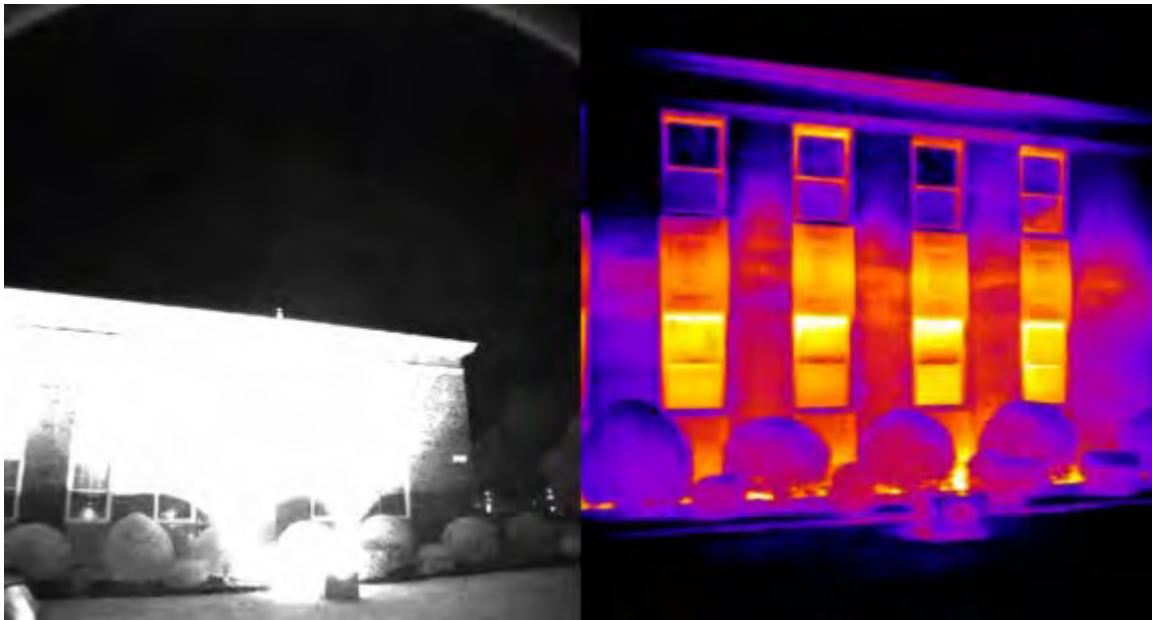
Figure 5-7. Insulation holes in Bldg 1, Camp Lejeune, NC.

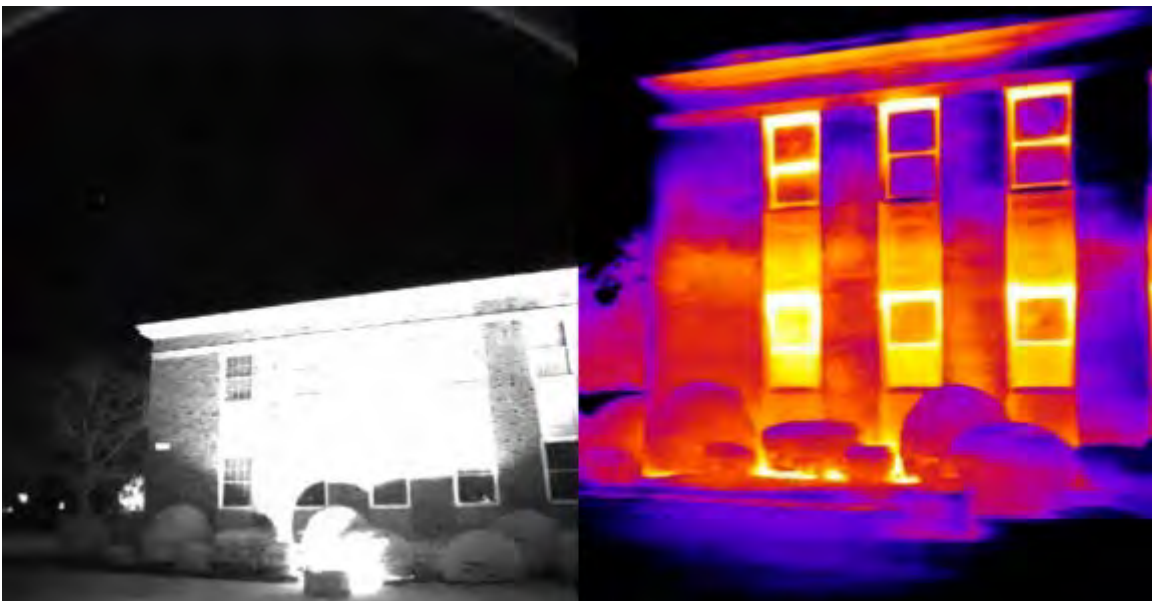
Figure 5-8. Additional wall insulation holes in Bldg 1, Camp Lejeune, NC.

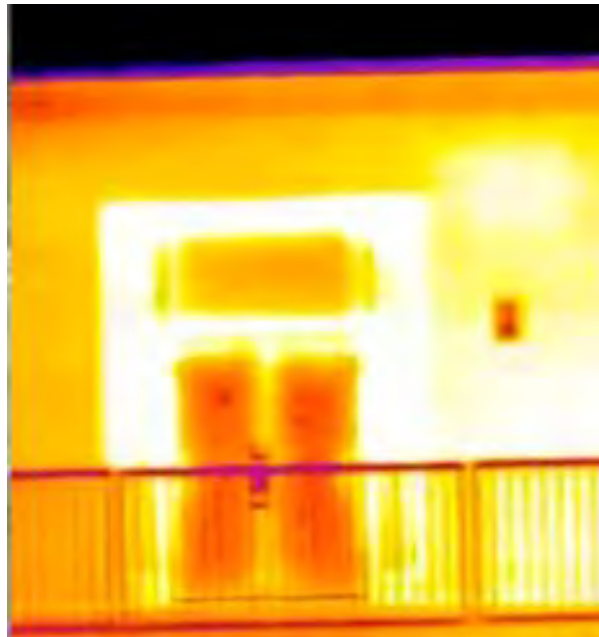
Figure C-4. Example of door frame energy leaks, Camp Lejeune.

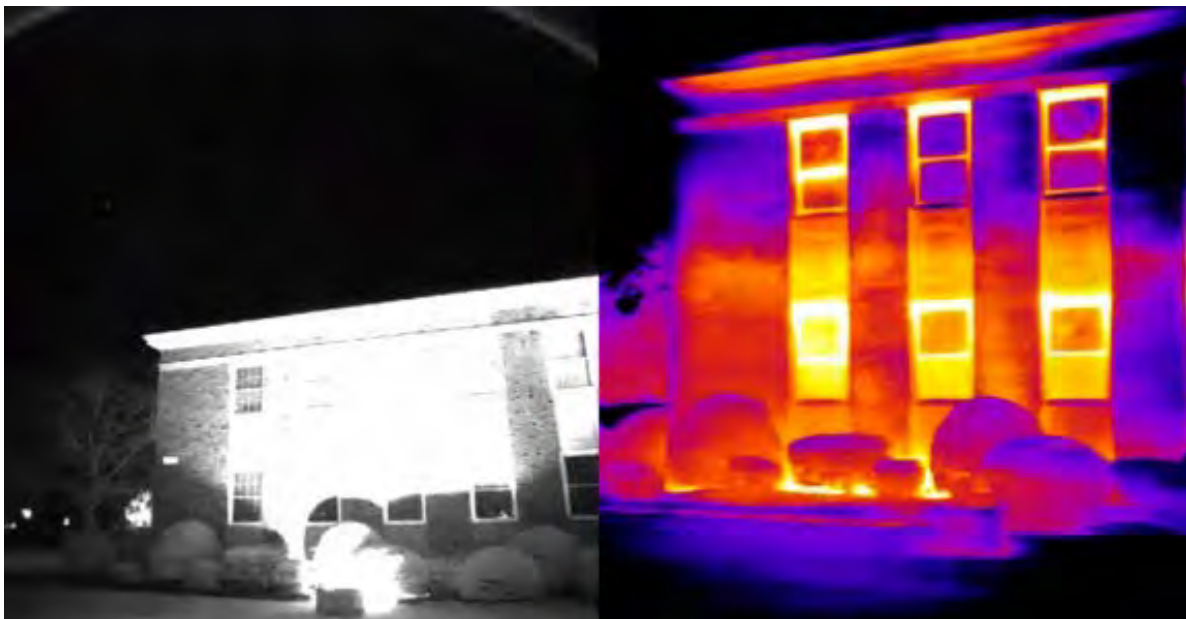
The wall at timestamp 323:22 is also highly emissive, and has some apparent insulation holes near the middle of the wall (Figure D-4). The soffit is also fairly emissive, and the window frames in the upper left are potentially leaky.

Figure D-4. NIR image (left) and thermal image (right) of Bldg 1, Camp Lejeune. Note apparent insulation holes near the middle of the wall, a fairly emissive soffit and apparently leaky window frames.

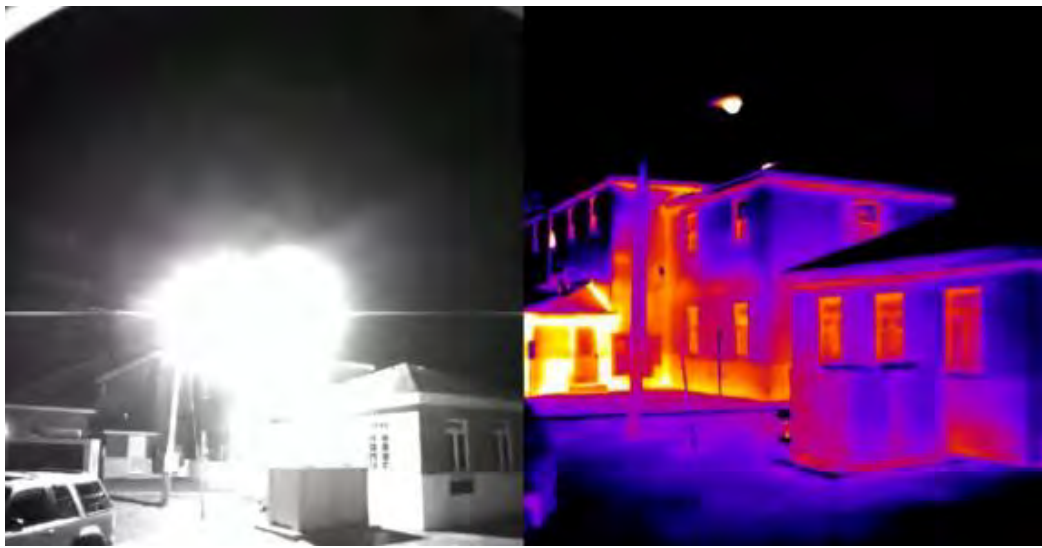
The wall near the center of the building at timestamp 91:23 and the exposed foundation/basement wall are highly emissive, which indicates poor insulation (Figure D-23).

Figure D-23. NIR image (left) and thermal image (right) of Bldg 18, Camp Lejeune. The wall near the center of the building and the exposed foundation/basement wall are highly emissive.

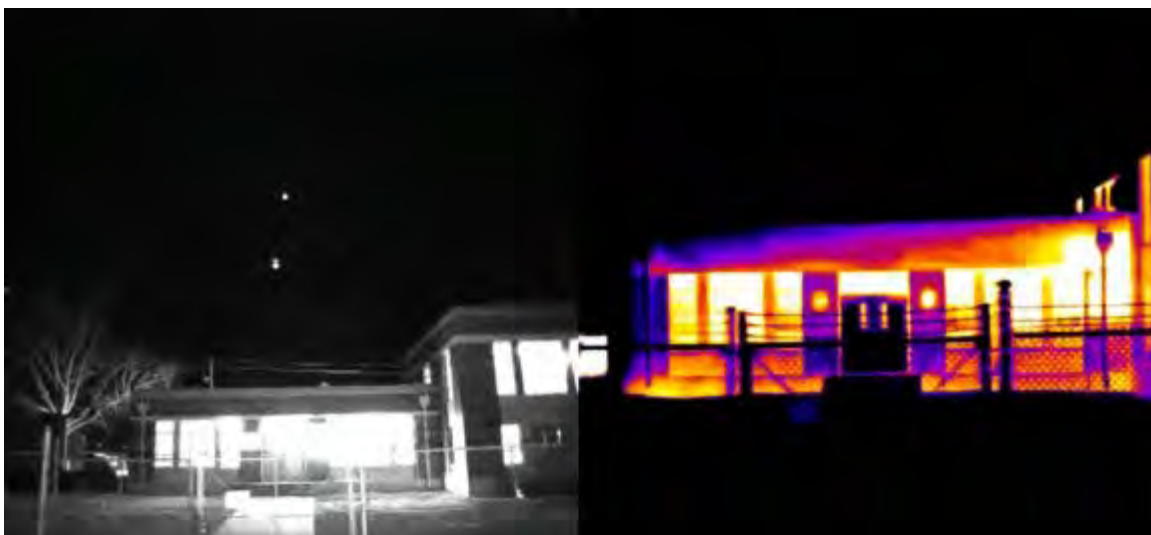
The windows visible at timestamp 313:16 are notably emissive. There are also some leaks along the door in the center of the image (Figure D-28).

Figure D-28. NIR image (left) and thermal image (right) of Bldg 20, Camp Lejeune. The windows are notably emissive and there are leaks along the door in the center of the image.

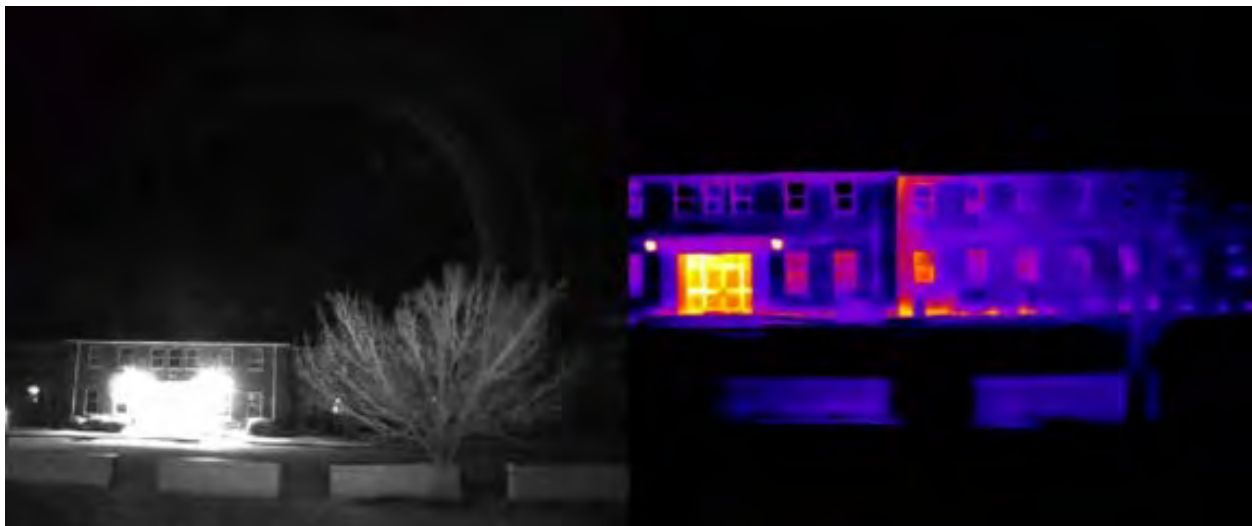
There are some leaks near the foundation at timestamp 134:49. The door-frame is also particularly emissive (Figure D-41).

Figure D-41. NIR image (left) and thermal image (right) of Bldg 58, Camp Lejeune. Note leaks near the foundation and at the door frame.

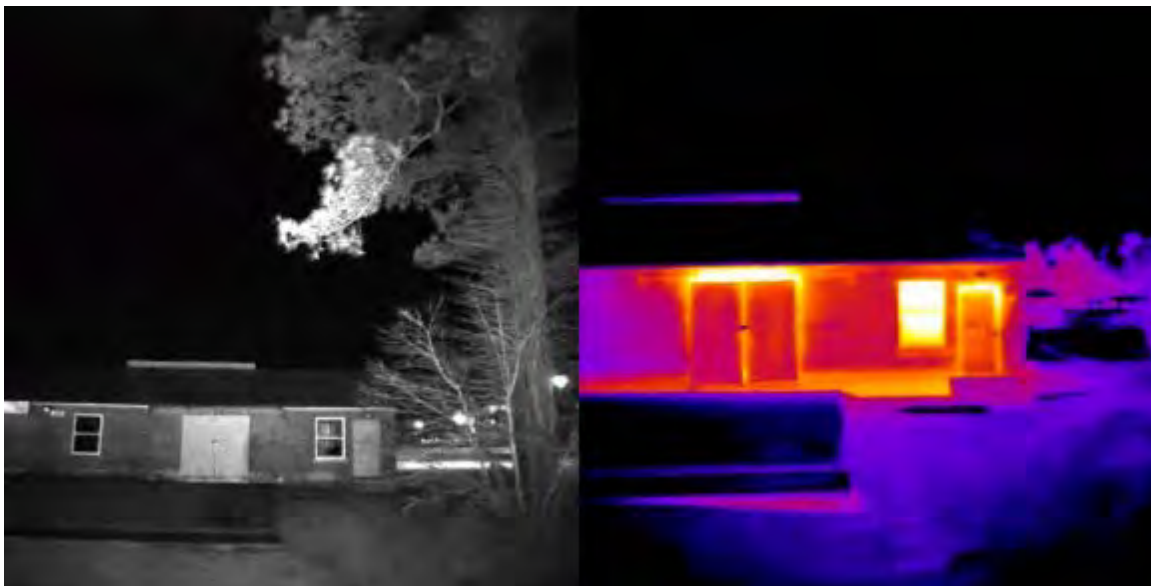
The door frames and window frame visible at timestamp 87:43 are unusually leaky (Figure D-50).

Figure D-51. NIR image (left) and thermal image (right) of Bldg 116, Camp Lejeune. The door frames and window frame visible are unusually leaky.

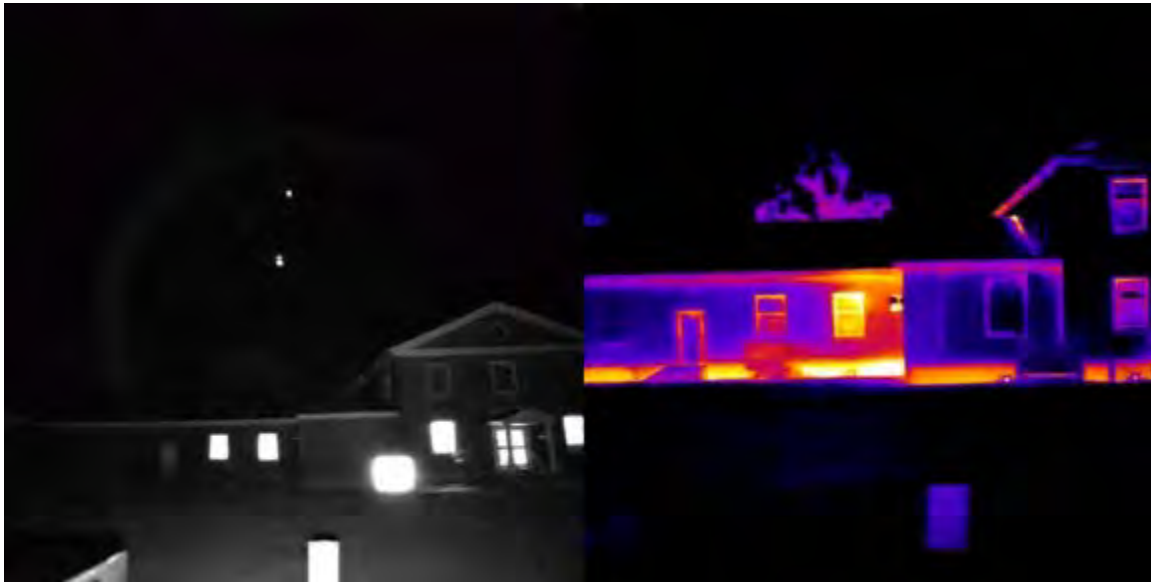
The window frame near the center of the image at timestamp 312:57 is quite emissive, as is the foundation and soffit (Figure D-87).

Figure D-87. NIR image (left) and thermal image (right) of Bldg 322, Camp Lejeune. The window frame, foundation and soffit are also quite emissive.

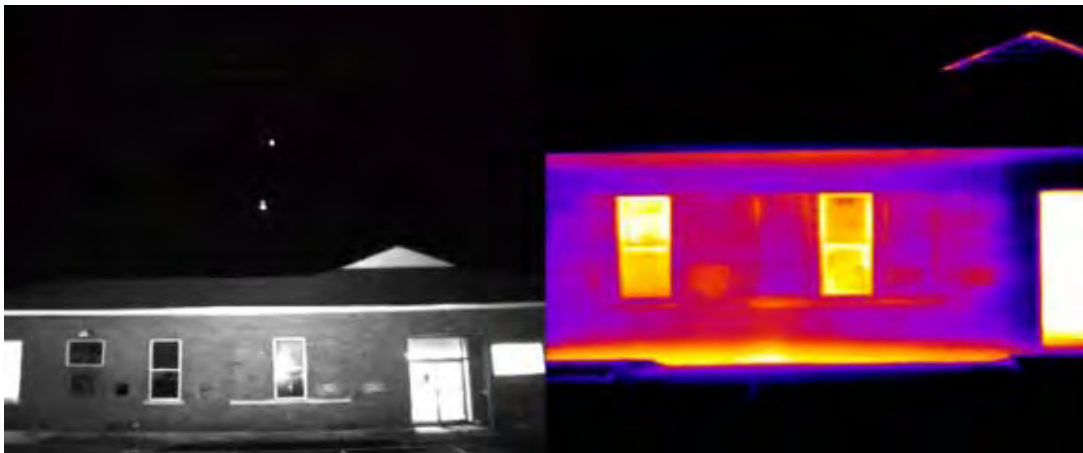
The wall at timestamp 356:57 has a hot spot around the center of the image, and the exposed foundation/basement wall is also quite emissive (Figure D-101).

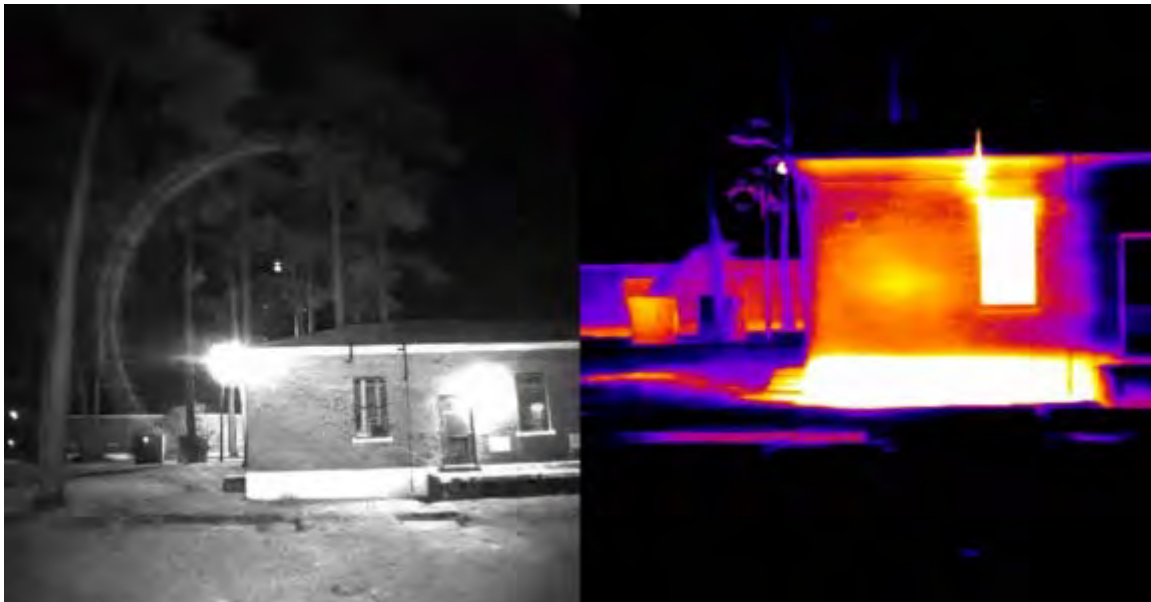
The wall in the center of the image at timestamp 353:22 is highly emissive, with a large warm hot spot in the center and an emissive foundation/basement wall (Figure D-115).
